# PROJECT MICHAEL

Technical Report No. 3C

Behavior of M.A.C. Mints on the Bottom of the Hudson River

August 31, 1954

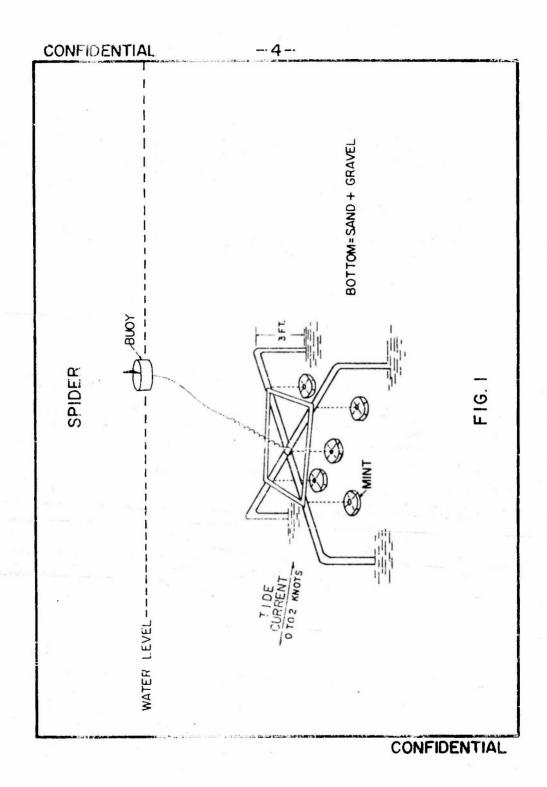
The reference consisted of a spider constructed of metal tubing which could be anchored firmly to the bottom but would not interfere with the mints in case they drifted with the current. The spider (See Fig. 1) had four horizontal arms, each about 9 ft long, and with vertical legs 3 1/2 ft long on the outer end of each arm.
